### FOCUS ON THE NORTH-EAST

### Power line observations: Caprivi & Kavango (14-17/6/10)

## POWER LINE SURVEYS

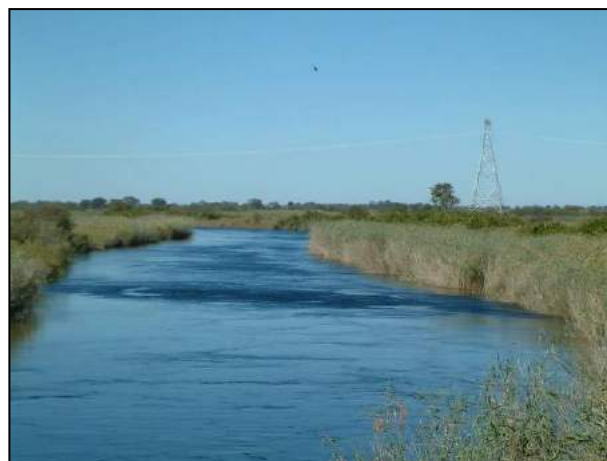
**Top:** The 350HVDC line crossing at the wetlands of the Kwando River at Kongola, Caprivi.

Solar-powered lights and double spiral bird flight diverters have been fitted as a proactive mitigation measure at the large Kwando River crossing of the 350HVDC line in Caprivi, where concentrations of bird life are greatest.

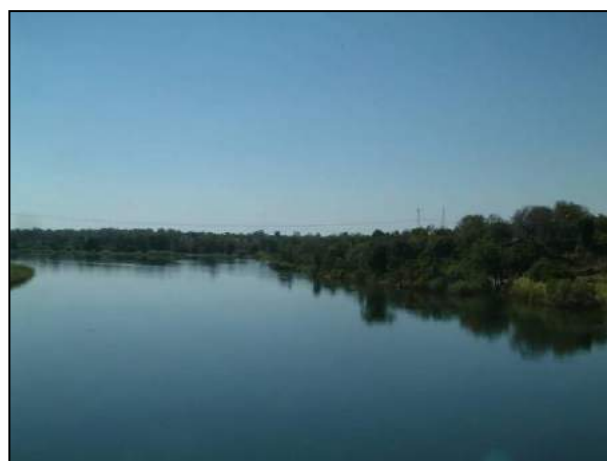
**Centre:** The 350HVDC line crossing at the Kavango River at Divundu, Kavango.

The same mitigation measures as above have been fitted as a proactive mitigation measure at the large Kavango River crossing of the 350HVDC line in Kavango.

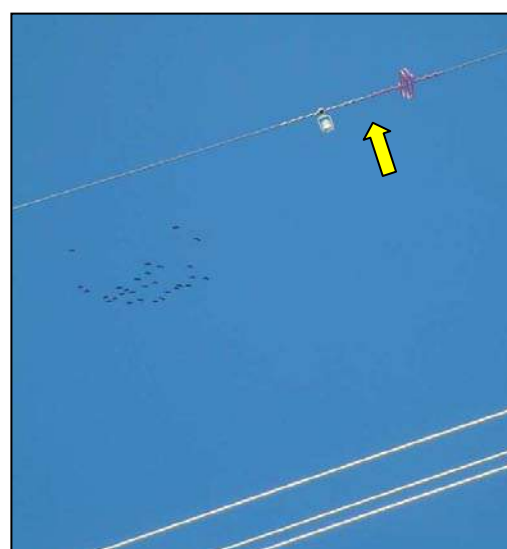
**Bottom:** Solar-powered light (left) and red double spiral bird flight diverter fitted at the Kavango River crossing at Divundu; a flock of storks circles overhead (photos Ann Scott)

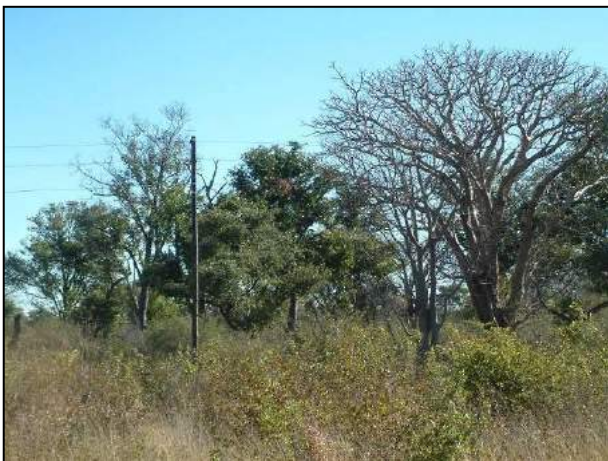
Vegetation is woodland with bush and trees, some parts cleared for agriculture; dense in riverine areas; extensive wetland areas. In bushy habitats, smaller power lines (such as HLPCD lines west of Katima Mulilo) become less visible to birds flying at this height.

In bushy habitats, power lines (such as this smaller HLPCD line west of Katima Mulilo) become less visible to birds flying at this height (photo Ann Scott)

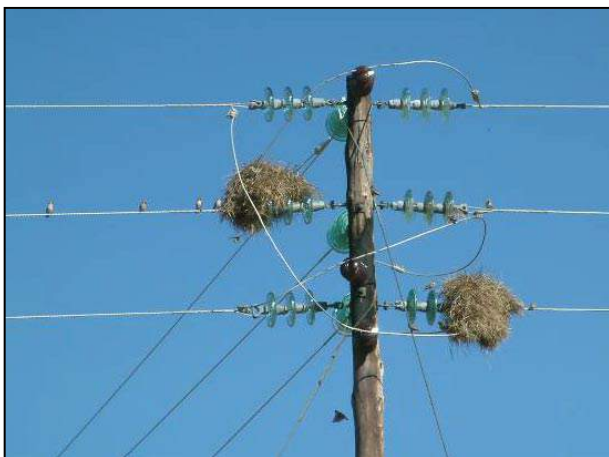
Many Sociable Weaver nests on the 33 kV lines, mainly on the glass insulators, result in outages and damage to insulators, and sometimes fires. These nest constructions need to be removed frequently, and are replaced soon afterwards. These birds also nest on transformer structures.

The availability of water near a homestead has apparently attracted many Sociable Weavers to this site, resulting in persistent nesting on insulators; the regular removal of these nests necessitates a round trip of 320+ km by NamPower personnel every week (*photo Ann Scott*)

- Continue to seek solutions for the ongoing Sociable Weaver nesting problem; experiment with an integrated strategy, e.g. dummy pole (try using an old windmill tower) together with removal of nesting material and silicon grease at original site; investigate noise deterrents.
- Liaise with NamPower staff in the Aranos area, where dummy poles have been used successfully.

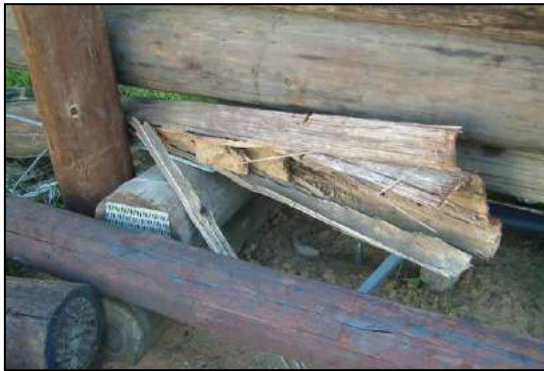
Damage caused by termites to creosoted Erongo RED power line poles at Omaruru (photo Ann Scott)

- Baboons have caused outages on the 11 kV Otjompauwe line, blowing fuses.
- Genets climb up to birds' nests on transformers and cause outages. Transformers are expensive to replace.
- Dangerous snakes (e.g. black mamba) are found on Sociable Weaver nests; sometimes snakes are electrocuted on structures.
- Termites can cause damage to creosoted poles, which eventually collapse (see photograph above).

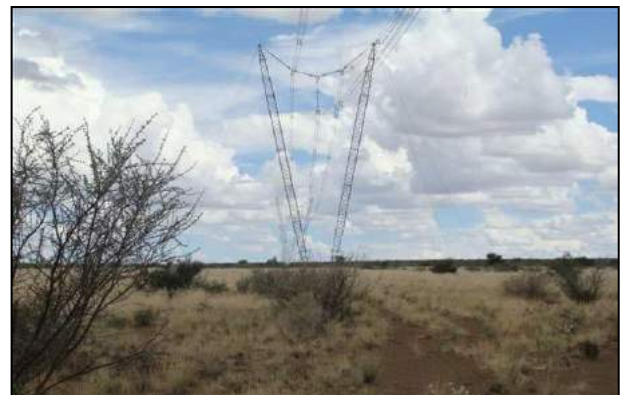
**Bottom:** Remains of what appears to be a Black-chested Snake-eagle (above), and two bustards (below) (photos Pieter Cloete)

**Black-chested Snake-eagle:** collision/mortality  
 Tower 62 & 63 / 26 15.852S 18 15.483E  
 1 x 10/06/2009 and 1x 30/11/2009 on same transformer;  
 only skeleton of bird left

**Bustards x2:** collision/mortality  
 Tower 102-103 / 26 02.191S 18 08.751E  
 22/1/10; only feathers of second bird left

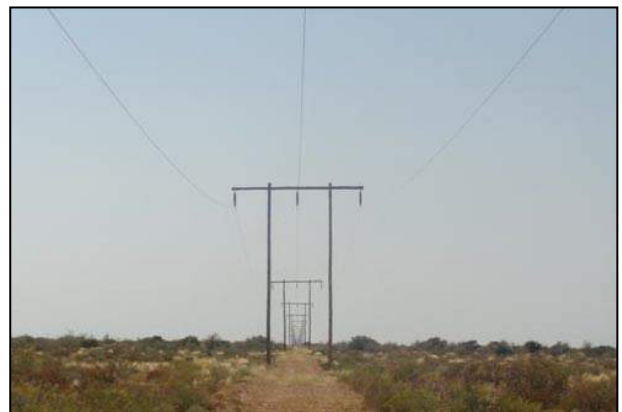
**Bustard:** collision/mortality  
 26 15,765S 18 52,250E  
 Carcass one month old, mid-line, eaten by scavengers  
**Bustards x2:** collision/mortality  
 26 11,005S 19 07,294E  
 Carcass one month old, mid-line, eaten by scavengers  
**Black-chested Snake Eagle (adult):** collision/mortality  
 26 07,916 S 19 13,562E  
 Carcass three weeks' old, mid-line, eaten by scavengers

**Bottom:** Remains of two bustards on the Kokerboom-Nabas 66 kV line (above) and remains of a Black-chested Snake-eagle (below; photos Pieter Cloete)

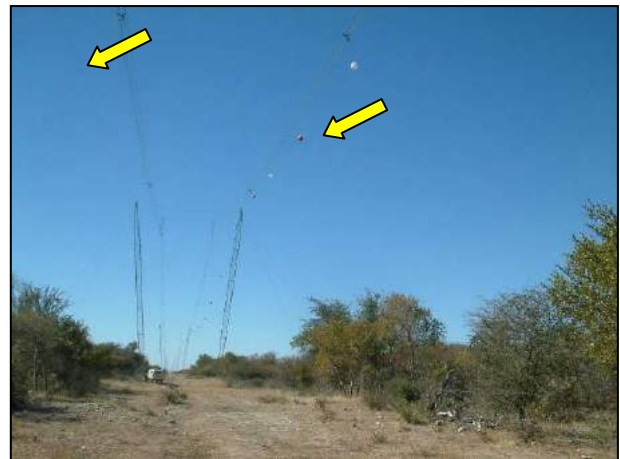
Mitigation: Red double spiral bird flight diverters had been attached to both upper lines at 20m intervals, from Tower 457 to 491, before the collision event. However, these visual markers are not effective for warning birds that fly at night.

**Centre:** Structure of the 350HVDC line; near-invisible earth wire and optic cable are indicated by arrows (left: marked with red bird flight diverters; and right: marked with red flight diverters as well as red and white balls, standard for road crossings).

- Investigate further mitigation in problem areas, as soon as sufficient information is available. The Mace Bird Lite and blinking solar powered aviation lights attached to the earthwires could be tested on an experimental basis. Auditory/ultra-sonic warning devices should also be investigated.

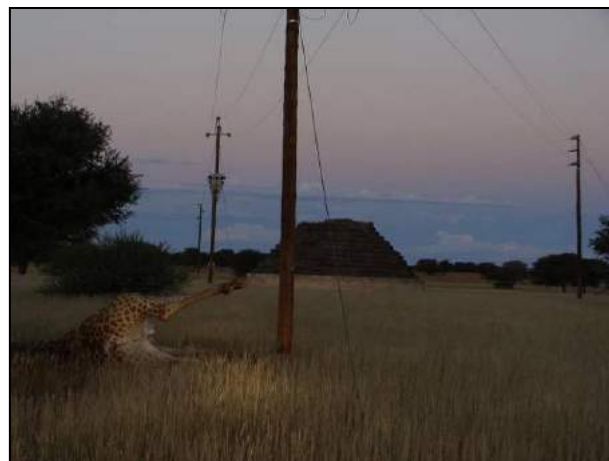
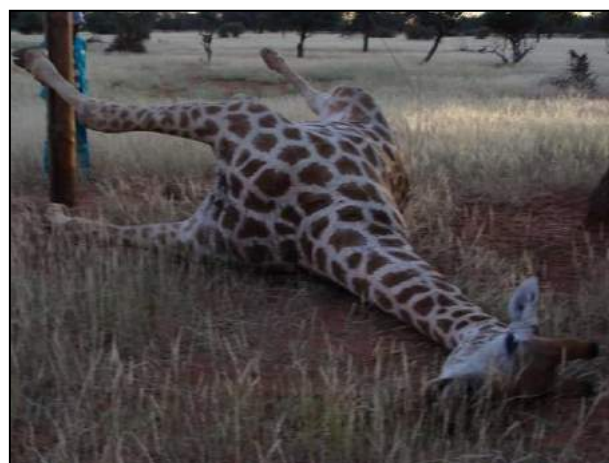
Omstreeks 16h00 Vrydag 23/04/2010 het Mnr. Schalk de Waal my telefonies gekontak en rapporteer dat sy kameelperdbul deur NamPower kraglyn gedood is. Hy het my gevra om ook uit te gaan na Monika-Oos sodat ek myself kan verwittig en ons die insident kon bespreek.

Giraffe mortality on the Monika-Oos power line, Aranos (photos AC van Zyl)
