### THE NAMPOWER/NNF STRATEGIC PARTNERSHIP: TWO YEARS DOWN THE LINE

## POWER LINE SURVEYS

## POWER LINE/WILDLIFE INCIDENTS

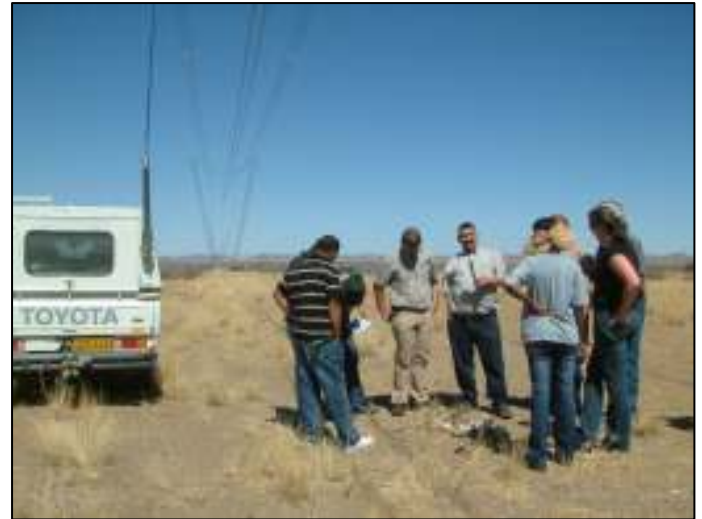
Concerned participants at the Bustard and Power Lines Workshop at Keetmanshoop in October 2010 examine the remains of a Black-chested Snake-eagle that had collided with the Kokerboom-Aries 400 kV line (photo Ann Scott).

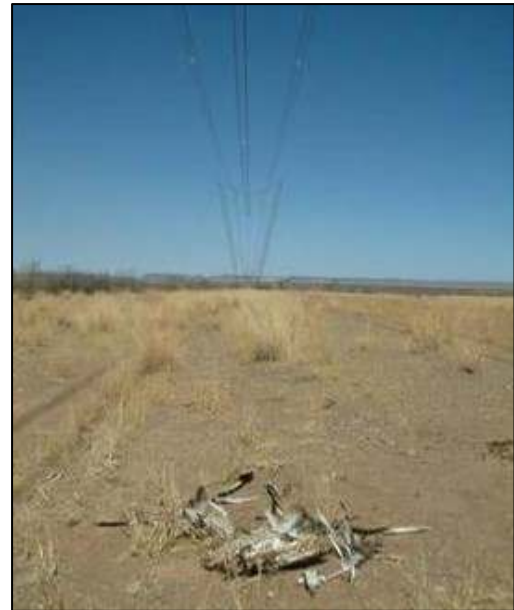
The Bustard and Power Lines Workshop included a survey of the 400 kV Kokerboom-Aries line near Keetmanshoop on 12 October 2010, when the carcasses of six bustards (including this female Kori Bustard) and two raptors were found over a distance of 11.5 km (*photo Ann Scott*).

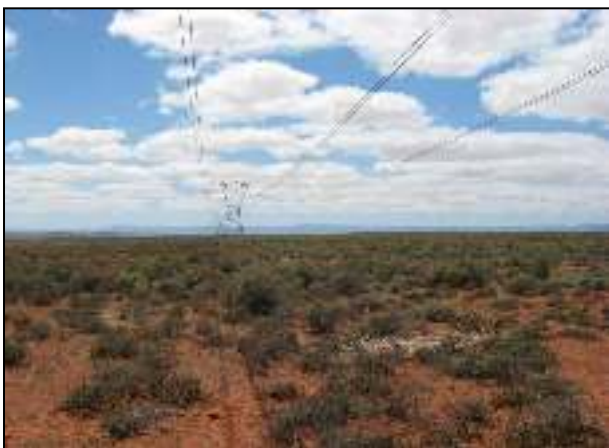
On my October 2010 survey of transmission power lines in the Karoo, I recovered a huge number of Ludwig's Bustard mortalities on one section of the 400kV Helios-Juno line. In three months, at least 34 bustards died in just 20 spans, which highlights their extreme vulnerability to collision. The section is on top of a ridge, and has a few broken old-style flappers on one earth wire, so has clearly been a problem in the past. While the bustard numbers in the area have been high in the last few months, it is still an exceptionally high collision toll, and is a minimum estimate – most remains had been completely scavenged so it is probable that we didn't count all birds that died.

The collision hotspot from Jessica's last survey: unfortunately there were mostly only feathers left but three feather "sprays" can be seen (photo Jessica Shaw).

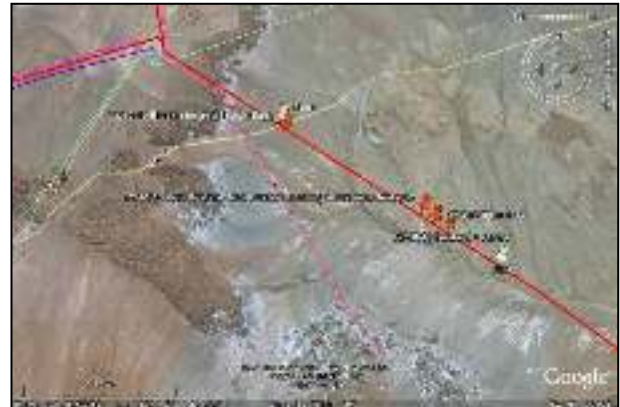
Google image of the area investigated, showing sites of eight incidents (see below) that are clustered mainly in an area where the 400 kV power line (red) runs parallel to a watercourse; other colours represent different power lines/roads (based on a Google map generated by Alice Jarvis [EIS]).

The area has a high potential for wildlife/power line interactions due to the convergence of several power lines, dry watercourses and strong winds experienced. Problems have been recorded previously in the same area on 10/11/09 (three carcasses) and 19/11/09 (five carcasses). The habitat is open with gravel; sparse grass and some bush. More bushy in the (dry) watercourse running NW to SE; windmill and stock water point nearby.

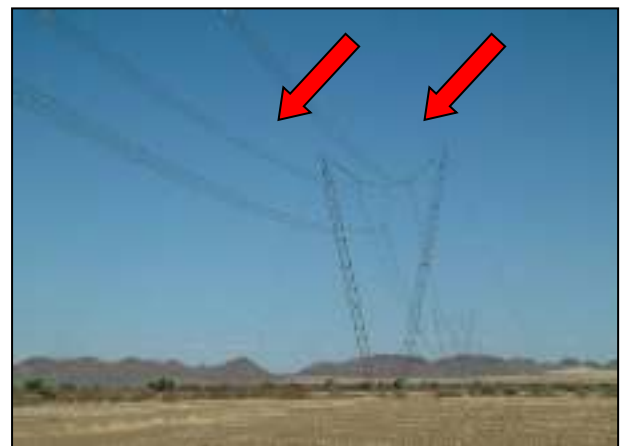
Structure of the 400 kV Kokerboom-Aries line; near-invisible earth wire and optic cable are indicated by arrows (photo Ann Scott).

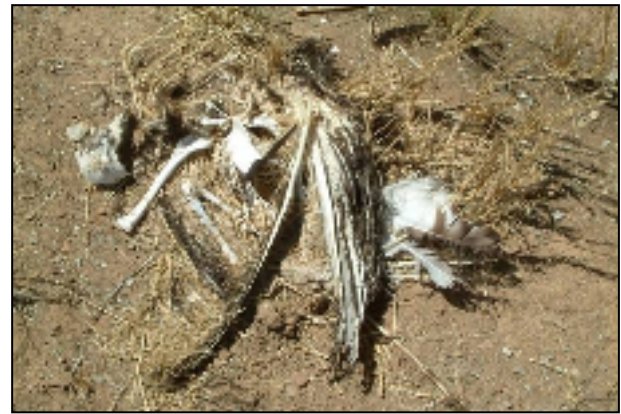
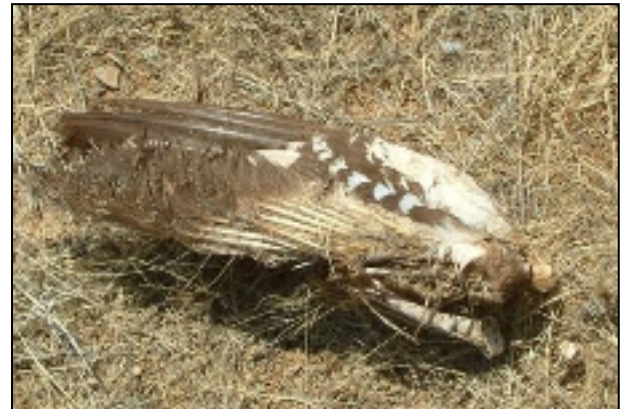
Mortalities on the Kokerboom-Aries 400 kV line survey included a Kori Bustard (adult female; above) and an unidentified bustard (below; photos Ann Scott).

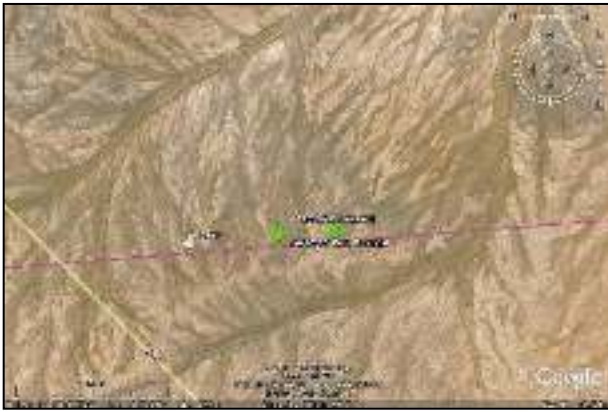
Kori Bustard (28.3885S 19.16736E, poles 234 - 235, midspan, 4m from centre of line on northern side (prevailing wind from south?))

Bustard (juvenile; carcass remains older than previous one; 28.38794S 19.17681E; poles 237-238; near pole, 15m north of line)

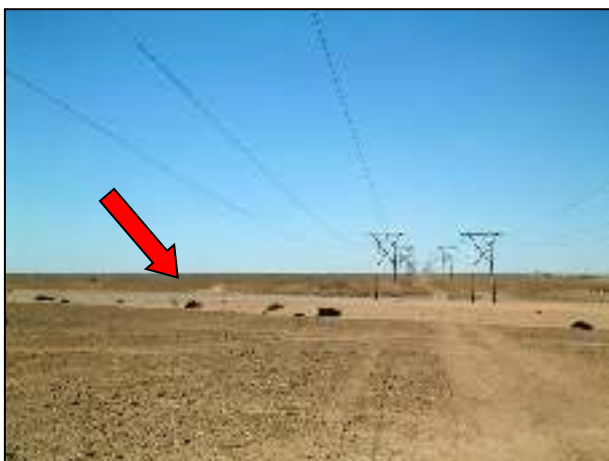
Structure of the 66 kV line with wooden poles and three large conductor wires, east of Walmund S/S. In this typical coastal desert habitat, dry water courses (red arrow) may be used as flight paths by nocturnally flying species such as flamingos, where power lines would be a potential collision threat (photo Ann Scott).

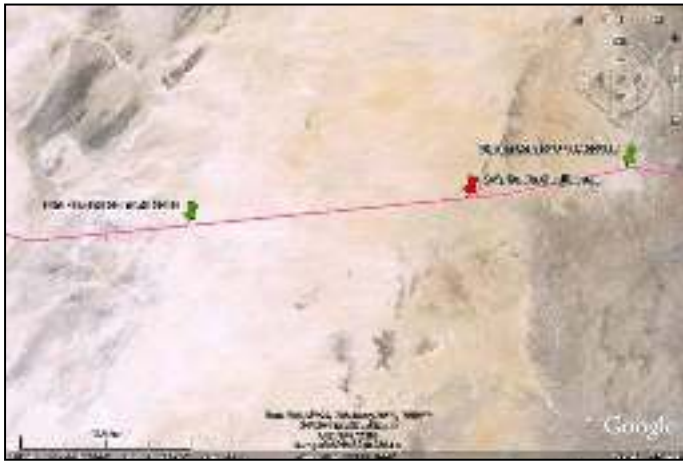
Top: Google image of the Ganab area investigated (green markers; 220 kV line = pink ); roads are yellow (based on a Google map generated by Alice Jarvis [EIS].

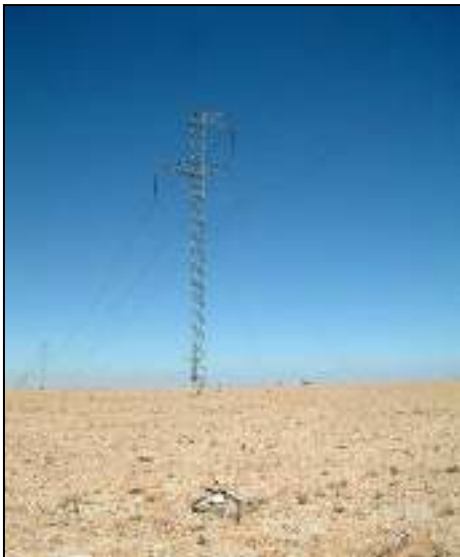
Centre: Remains of one of three bustards that had collided with the 220 kV power line.

**Bustard x3** (23.07856E 15.56656E, Tower 606-607; feathers only, fresh: 1x Ludwig's Bustard; 1x Kori Bustard; 1 unidentified bustard)

As the carcass remains were close together, it appears that the birds may have been following a flight path west of the rocky outcrop running north-south (see left).

Mitigation of this section of line with a suitable marking method is considered urgent (existing broken flappers should be replaced); see also p11.

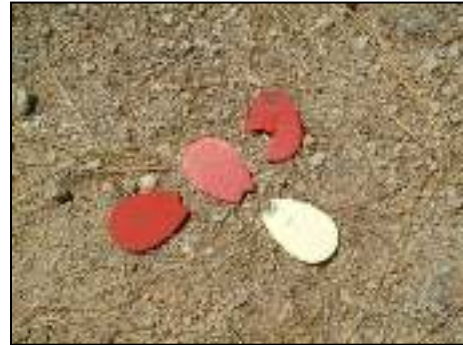
Red and white flappers have been fitted to most of the line surveyed; however, the majority have snapped off on the plastic part (see above); the fittings were still secure and evenly spaced). The terrain is open with good visibility of the line; however, the thinner earth/optic wire above the main conductors is a collision threat to both bustards and vultures.

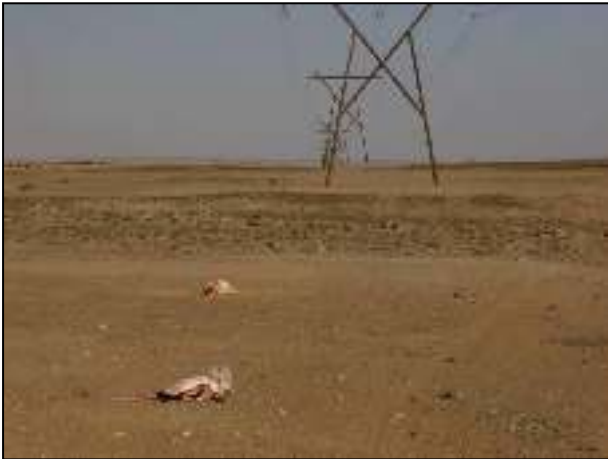
On 11/11/2010 at 17h00 two (Greater) Flamingos were found under the power line, about 100 m east of the generators at the NamPower substation next to the Wlotzkasbaken desalination plant. They appeared to have collided with 132 kV line, more or less midspan. The birds were still (just) alive when found, and taken to Dr Sandra Dantu in Swakopmund to see if they could be rescued. One died during the night, the other with a broken wing had to be put down the next morning.

What can be done to prevent such incidents? Seeing that flamingoes fly at night, is there a possibility of fixing lights to sections of the power line? I don't know if they are available here, but in Europe you get cheap solar-powered lights that store energy during the day and shine most of the night.

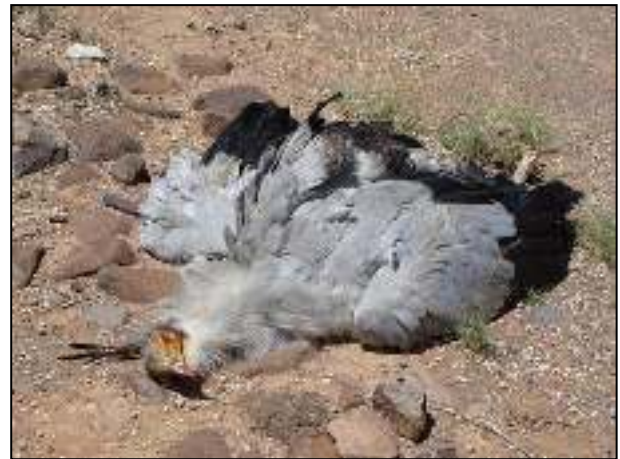
The 400KV Awas - Kokerboom/No: 6 line was inspected on 9 March 2010. The Secretarybird was found midspan between pole 498 – 496, next to border fence 251. The line route runs from north to south. The area is very flat, like a pan, and the bird was travelling from east to west. The carcass was very fresh (1-2 days). Must be in area between Hardap Dam ( Fish River) to Maltahöhe tar road. A dead cow was also found on the same line at Tower 637 on 6 March 2010; it was at midspan under 400 KV line next to border fence 251, on the western side. (A second incident involving a cow was handled by Mariental District.)

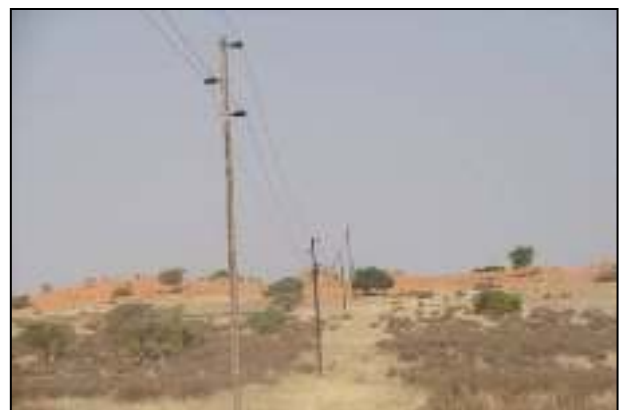
On 18/10/2010 two (Lappet-faced?) vultures collided with the Kiris 33 kV HLPCD retic. near Aroab (S26 27.861 E 19 37.224 – 200 m north of this reading). Only the skeletons of the birds were left. No. 1 collided midspan and No. 2 was on the pole.

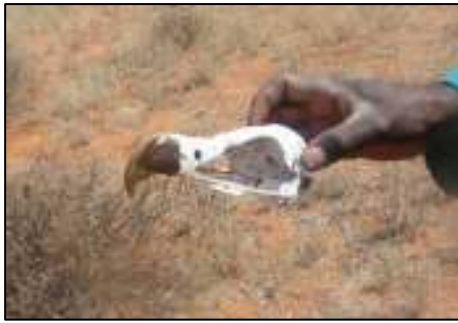
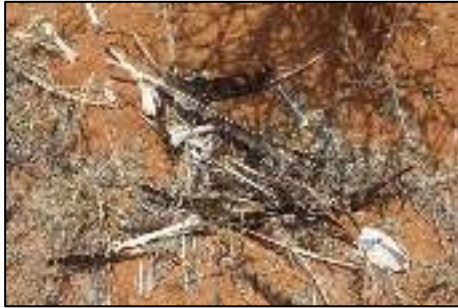
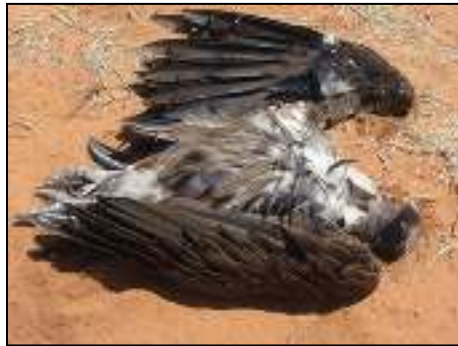
*Top:* The first vulture collided midspan on the Kiris 33 kV retic. near Aroab (see p11).

*Centre:* The remains of the second vulture were found nearer to the pole;

*Bottom:* A fresh White-backed Vulture carcass was found on the same line, 1 km away from the above two vultures, on 18/12/2001 (photos Pieter Cloete).

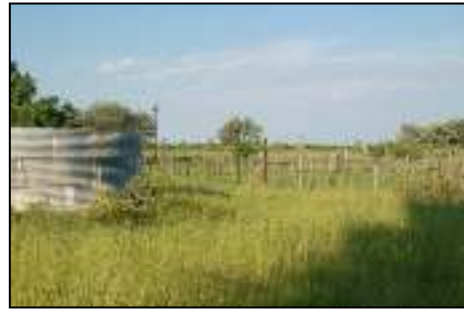
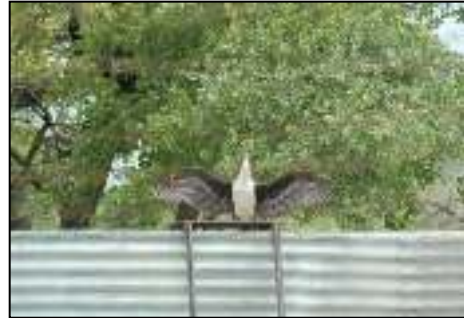
*Top:* Site of collision of a juvenile White-breasted Cormorant on a 11 kV line near Tsumeb;

*Centre:* The cormorant stretches its wings shortly before the collision;

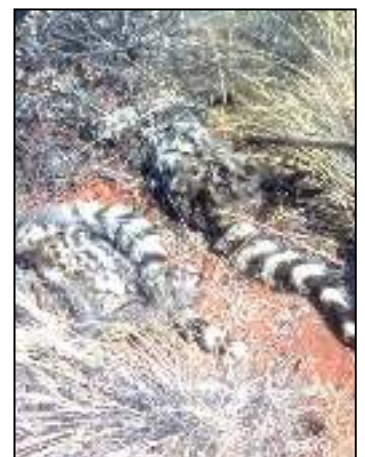
On 12/8/2010 at the Karas T-off S/S near Grünau, Karasburg district (S27°47'04,09" E18°29'00,4") a genet climbed onto the 22 kV jumpers and was electrocuted (see photo on right), causing a power outage.

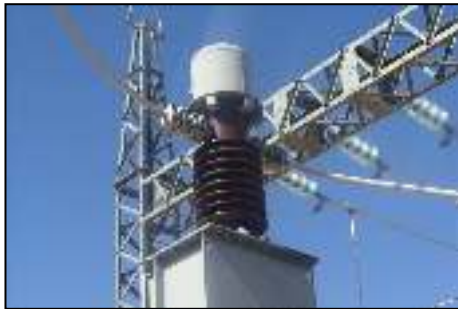
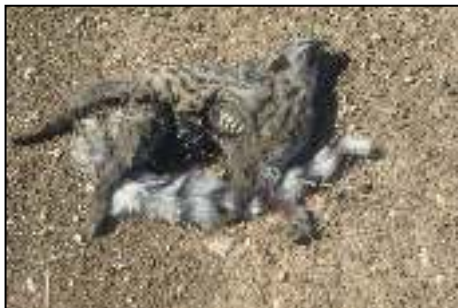
On 12/10/2010 at the Kokerboom S/S, Keetmanshoop district, one genet climbed onto the 33 kV CTs of transformer 31, was electrocuted and caused an outage (see photos below).

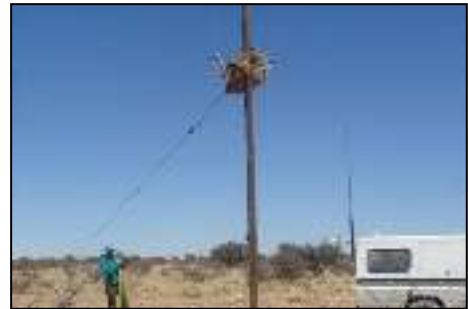
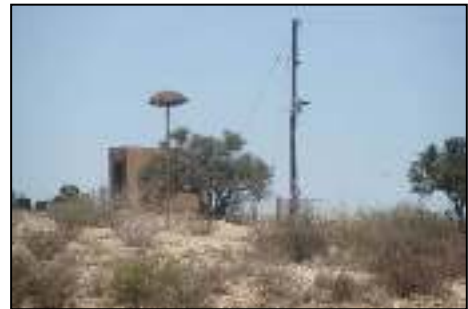
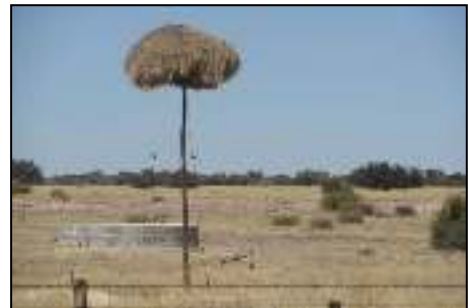
Dummy poles were used with success on an overshot 19 kV reticulation line (see photos below).

patterns and regular monitoring and removal of any signs of nesting on the original site; applying rubber silicon insulators; and making nesting 'baskets' of old conductors.

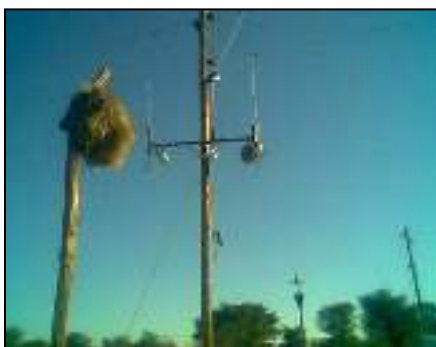
Effective management of Sociable Weaver nests in the Aranos area has **reduced outages from 11 to 2 (or less) per week**. Prior to this NamPower staff had to travel 186 km twice a week to remove these weaver nests. The integrated strategy includes the translocation of nests (see photo below), based on a study of local behaviour

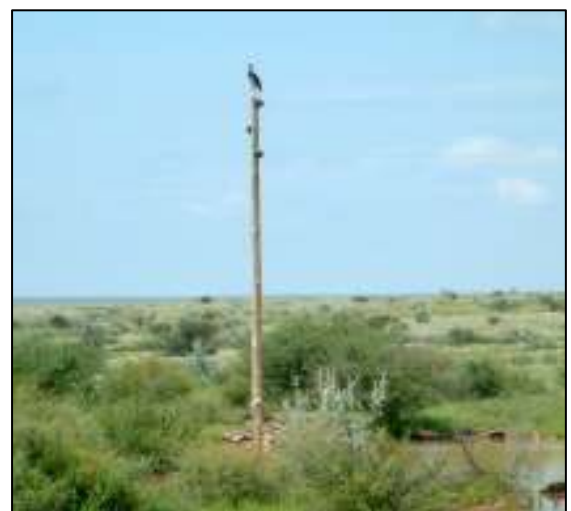
A Black Stork (Endangered; *Swartooievaar*) perches on a HLPD line on the C28 road between Mariental and Maltahöhe. The recent rains have attracted many wetland birds to ephemeral waterbodies, where such power line structures may be a potential threat (photo Ann Scott).
