### FOCUS ON THE NORTH-EAST

### Power line observations: Caprivi & Kavango (14-17/6/10)

## POWER LINE SURVEYS

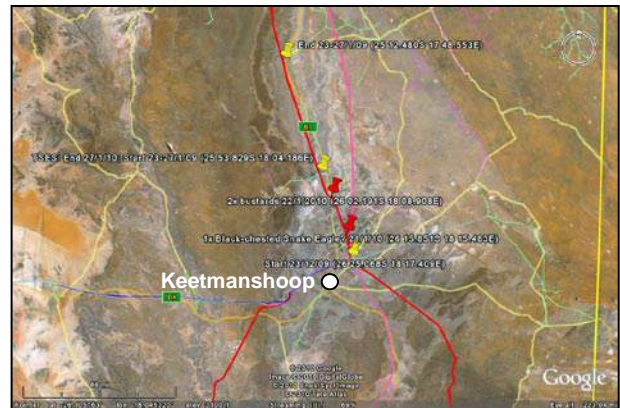
**Top:** Google image showing the Kokerboom – Auas 400 kV line in red, Tower 1-142 (lower two yellow markers) and Tower 143-323 (upper two yellow markers); sites of bird mortalities are indicated by red markers; country borders in bright yellow and roads in light yellow & dark blue; and other power lines in other colours (based on a map generated by Alice Jarvis [EIS])

**Bustard:** collision/mortality  
 26 15,765S 18 52,250E  
 Carcass one month old, mid-line, eaten by scavengers  
**Bustards x2:** collision/mortality  
 26 11,005S 19 07,294E  
 Carcass one month old, mid-line, eaten by scavengers  
**Black-chested Snake Eagle (adult):** collision/mortality  
 26 07,916 S 19 13,562E  
 Carcass three weeks' old, mid-line, eaten by scavengers

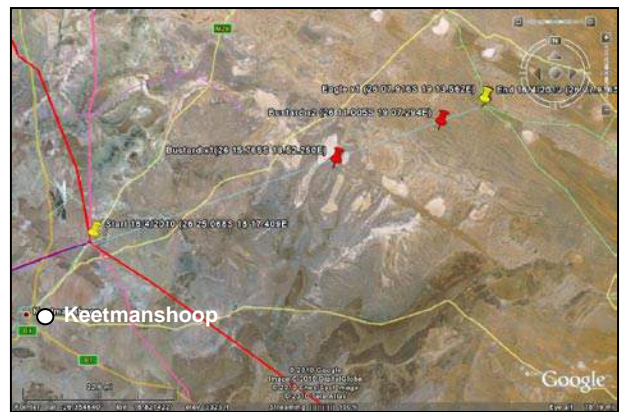
**Top:** Google image showing the Kokerboom – Nabas 66 kV line in pale blue (surveyed area between two yellow markers); sites of bird mortalities are indicated by red markers; roads in light yellow & dark blue; and other power lines in other colours (based on a map generated by Alice Jarvis [EIS]);

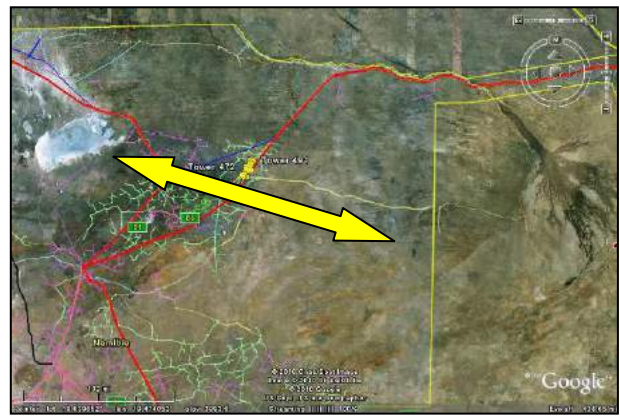
**Top:** Google image of the area investigated, showing site of flamingo collision incident (yellow markers) and flight path (yellow arrow) between Etosha National Park (left) and Bushmanland (based on a Google map generated by Alice Jarvis [EIS]); PTO for more detailed map.

The mortality of 20 flamingos is a cause for concern. As scavengers may have removed whole carcasses, this figure is considered to represent a minimum number of collisions. Both species are listed in the Red Data book;

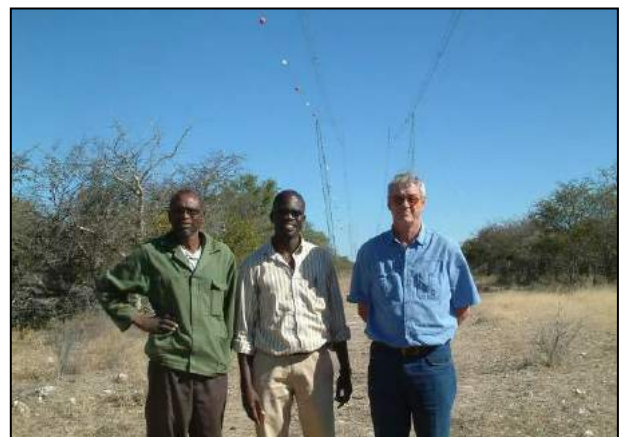
Mitigation: Red double spiral bird flight diverters had been attached to both upper lines at 20m intervals, from Tower 457 to 491, before the collision event. However, these visual markers are not effective for warning birds that fly at night.

**Centre:** Structure of the 350HVDC line; near-invisible earth wire and optic cable are indicated by arrows (left: marked with red bird flight diverters; and right: marked with red flight diverters as well as red and white balls, standard for road crossings).

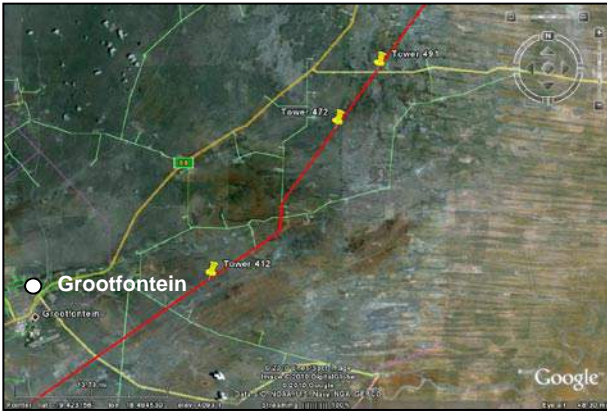
Detailed Google image of the area investigated (Tower 412-491), showing site of flamingo collision incident (Tower 472-491); the 350kVDC power line is indicated in red; roads are yellow; and other colours represent different power lines (based on a Google map generated by Alice Jarvis [EIS]).

Greater Flamingos and Lesser Flamingos are both classed as *Vulnerable*, while the latter species is also regarded as *Globally Vulnerable*. As predicted, the new 350kVDC line spans what appears to be a migratory route for these birds between Etosha and Tsumkwe. As the line has been recently commissioned, further events may be possible. If one were to multiply these minimum figures by the length of the line (and other similar lines) and per month/year, the result could be a significant off-take from the flamingo populations. The above findings would justify a much expanded monitoring survey in order to obtain some idea of the greater impact through large sample sizes, as well as any geographic trends. The recommendations below should therefore be considered as extremely urgent.
